ASSESSMENT OF NICD BLOCK B AND BLOCK C AT SANDRINGHAM

STRUCTURAL ASSESSMENT REPORT REV 0 AUGUST 2019

ASSESSMENT OF NICD BLOCK B AND C AT SANDRINGHAM

ASSESSMENT REPORT

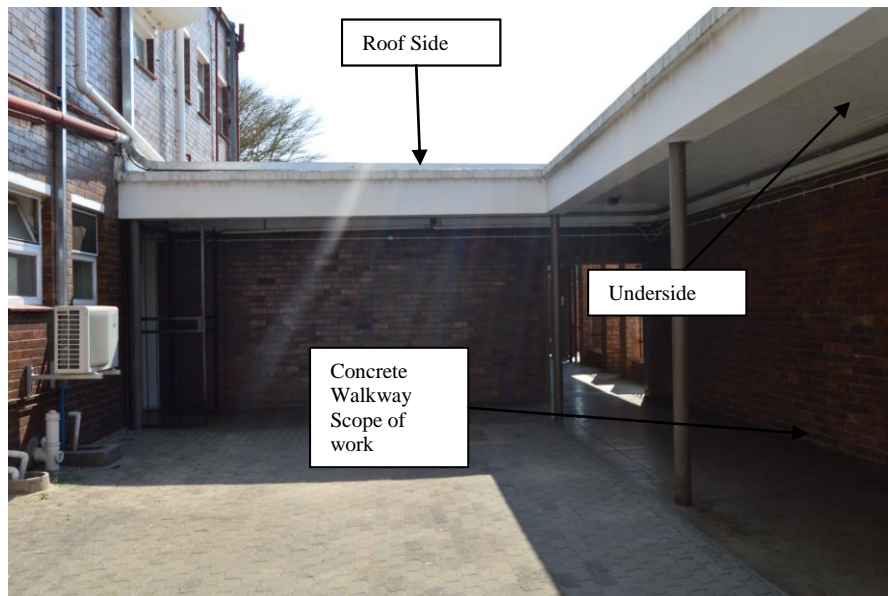
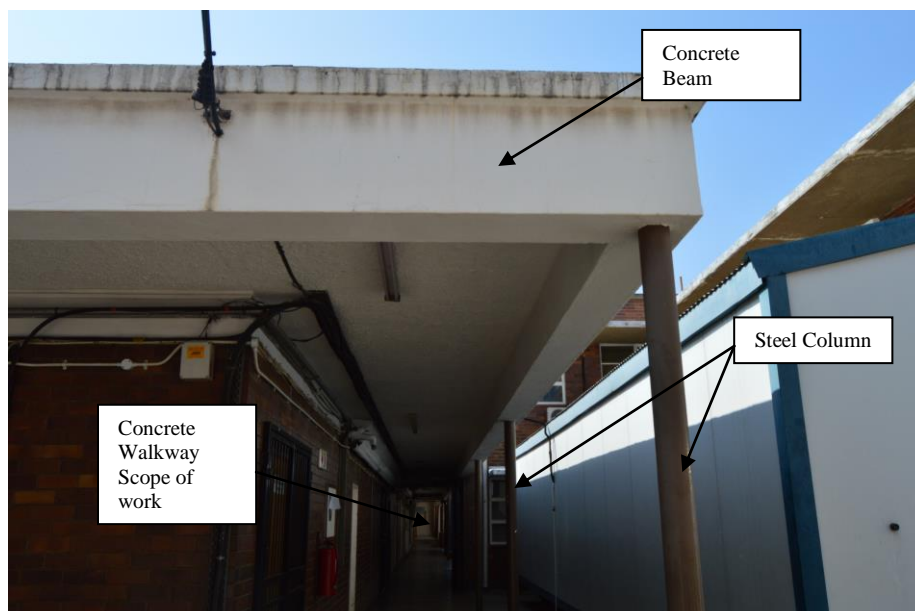
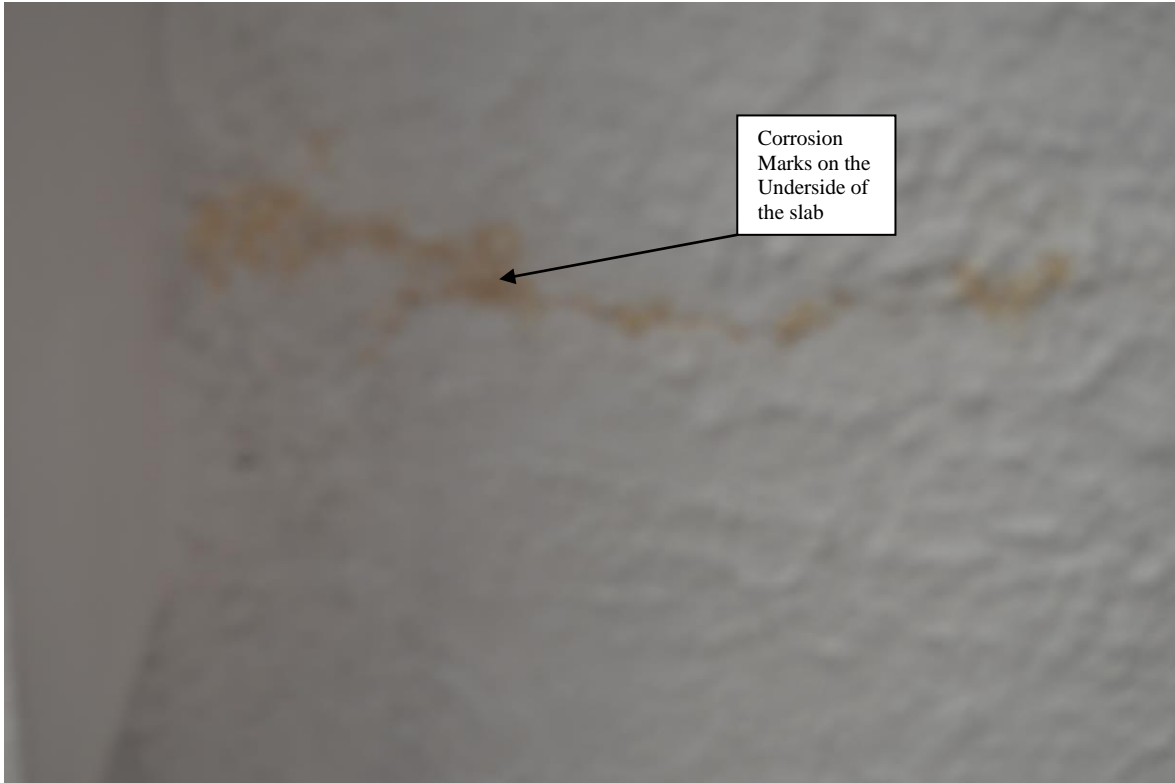
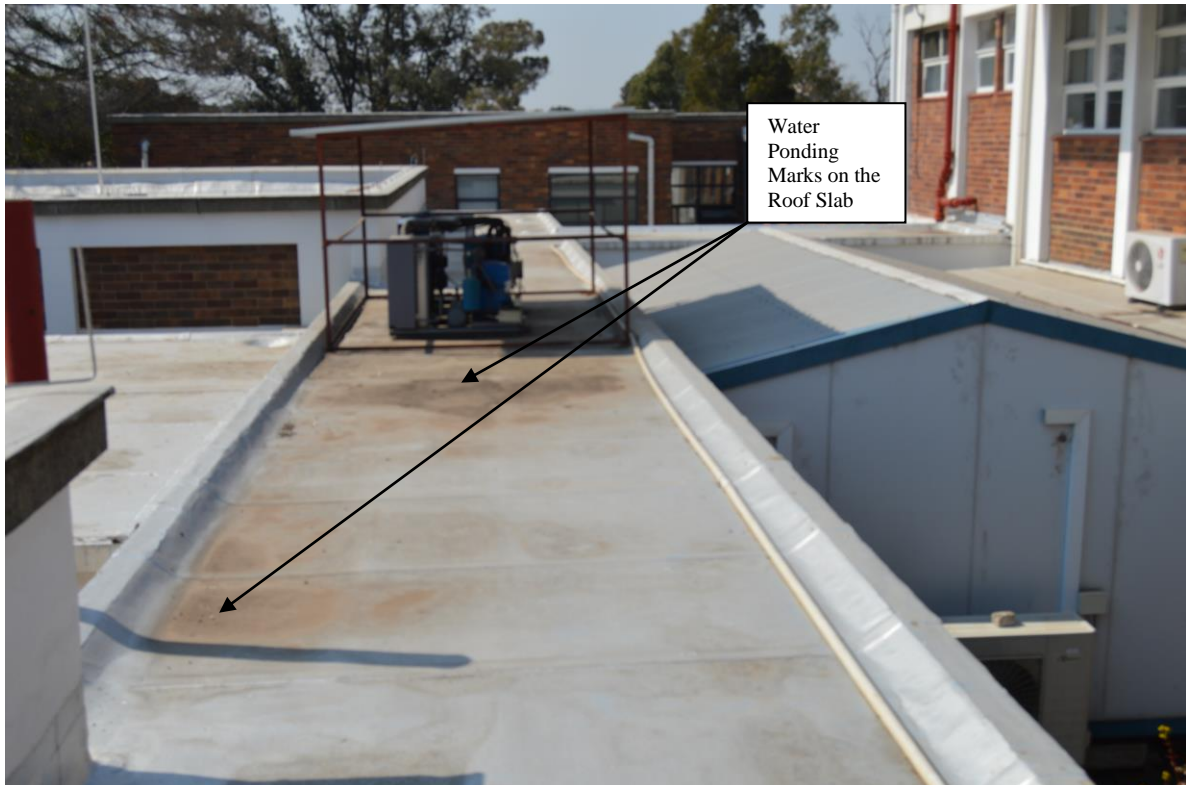
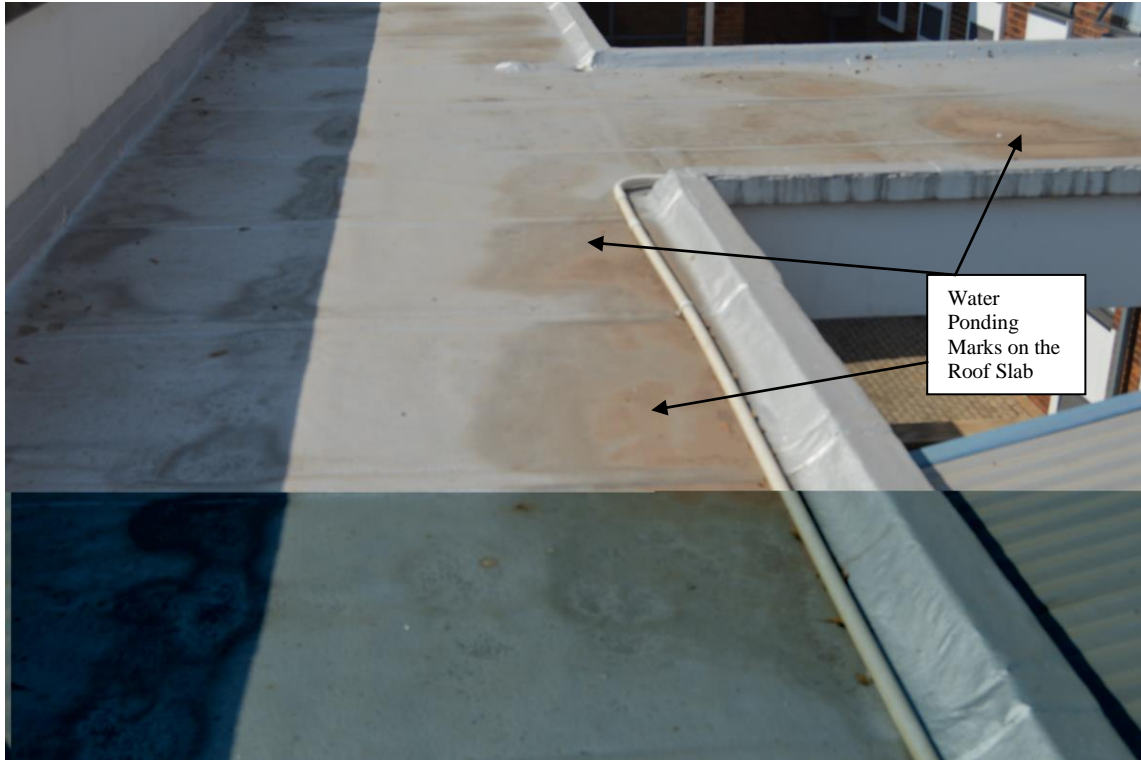
- Concrete canopy was recently painted underside and waterproofed membrane applied to the roof side. We have however noticed that there is no enough drainage point to drain the whole slab. We have seen water ponding spots which are highly detrimental to the concrete structure. The pictures below shows the water ponding on roof side and corrosion marks on the underside.

- Waterproofing membrane was not designed in such a way that it will direct water to the discharge point. We do not have a record of how long the reinforcement steel was exposed to rain water due to non draining slab. The effect of water ingress into concrete are however very detrimental to the integrity of the structure.

- Break open the existing slab on isolated problematic areas to clean oxidized reinforcement and reconstruct to original state by doweling and application of high strength drawing as recommended by **Appendix B**. Adequate support should be in place before any reinforcement can be exposed.
- Redesign the roof drainage system to remove ponding water on existing slab. The system should include screed to eliminate flat areas that result in ponding. Existing waterproofing membrane will be damaged and repaired should the screen be required. Provide gutters and downpipes to direct water to ground storm water system.
- Repair all the structural joints to prevent water leakage on slab.

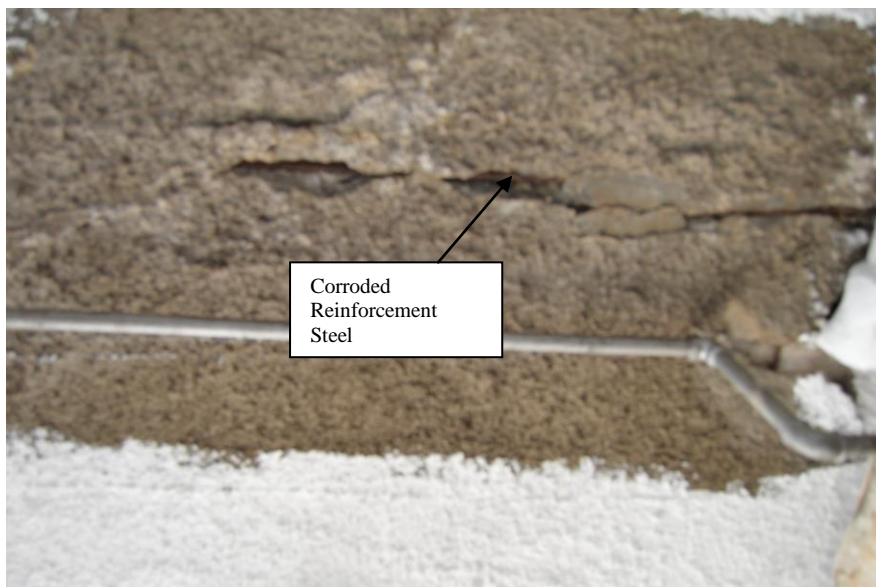
- We have noticed that most of the slab area is not draining during rainfall season. Water then finds a way into the concrete which is not allowed. Water result in corrosion of structural reinforcement which then weakens the structure. We could not check the state of corrosion as it destruct structural integrity. The picture below shows the corroded reinforcement steel.

- There is no water trapped in the slab.
- Concerned water stained areas identified in visual had slight oxidation of reinforcement bars.
- Concrete strength is still adequate for structural function. See **Appendix C**.
- Reinforcement beyond localized is still in good condition.
