06/09/2019

**Report National Health Laboratory Service
Modderfontein**

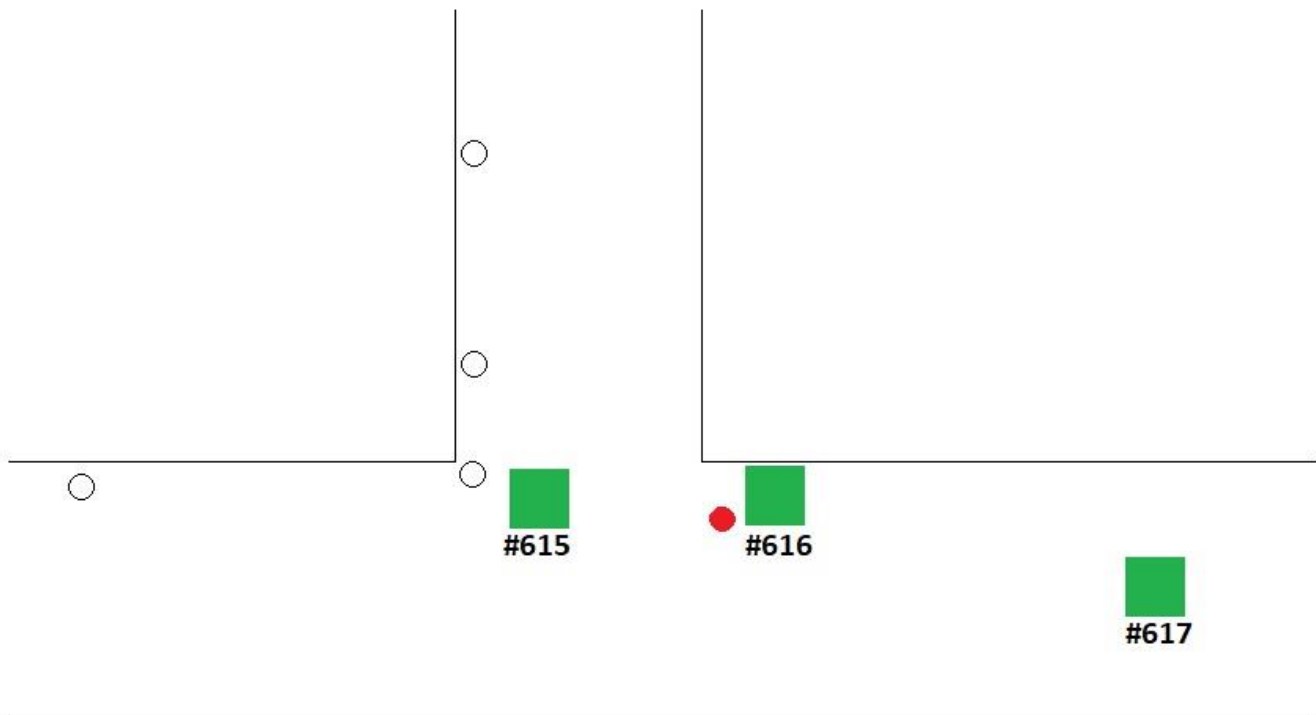
Please see the rudimentary drawing below for the position and orientation of scans and core sample.

*Core sample marked as a red circle.

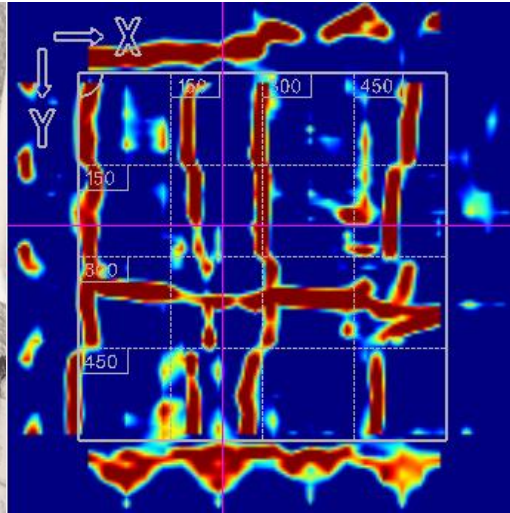
#615

- The scan was placed over the exposed damaged reinforcement.
- The scan did not detect excessive water in the area.

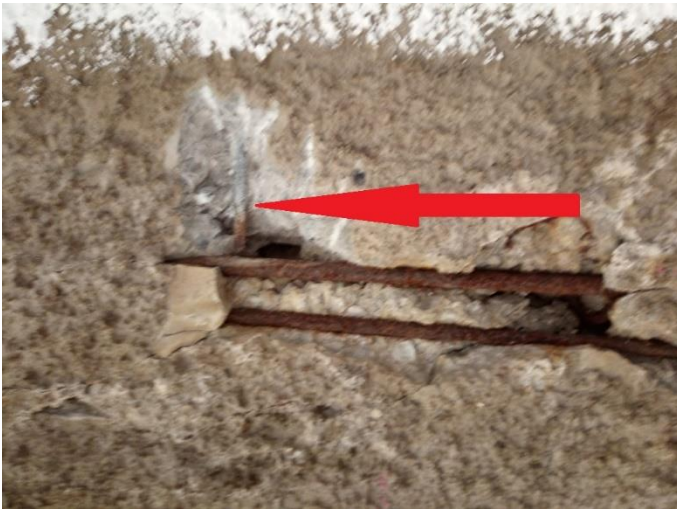
- This area appears to be the worst affected by water damage.
- Further reinforcement was exposed to observe how far the oxidation has occurred.
- It appears the water damage is localised in the one direction, please see red arrow indicating the end of the oxidation.

- We highly recommend exposing both top and bottom reinforcement in the areas where the water proofing has failed and the reinforcement has started oxidizing.
- This reinforcement should be mechanically cleaned with a wire brush and thereafter treated with an anti-oxidizing product.
- This exposed reinforcement should then be repaired with a high strength repair mortar. Thereafter the waterproofing should be reinstalled.

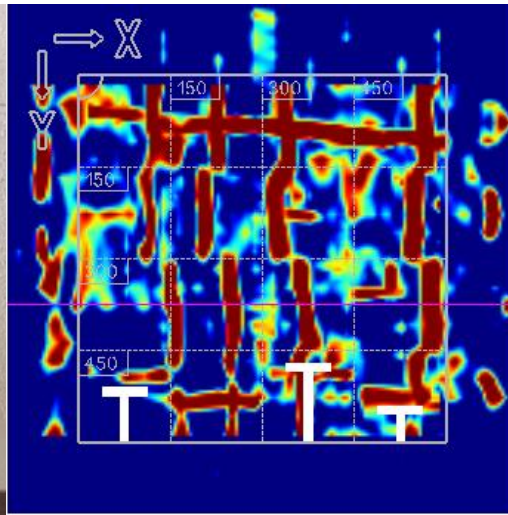
#616

- The scan did not detect excessive water in the area.

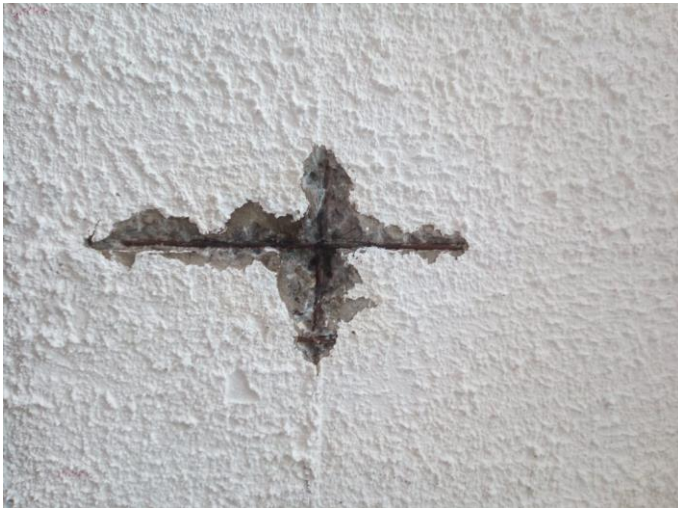
- The reinforcement in this area appears only slightly oxidized.

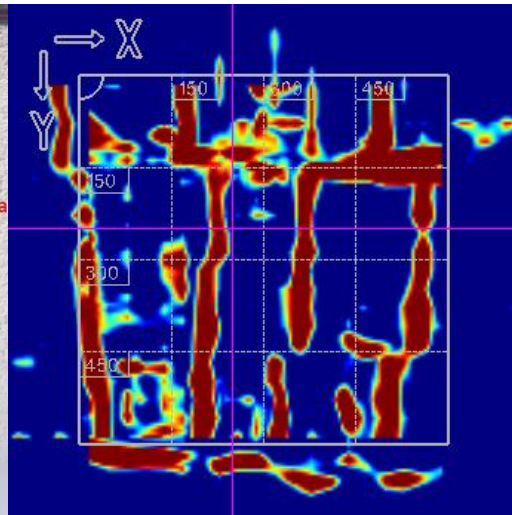
#617

- This area was chosen as it has a visible drip of water leaking through the slab.
- The area was scanned and only a small amount of water was detected.

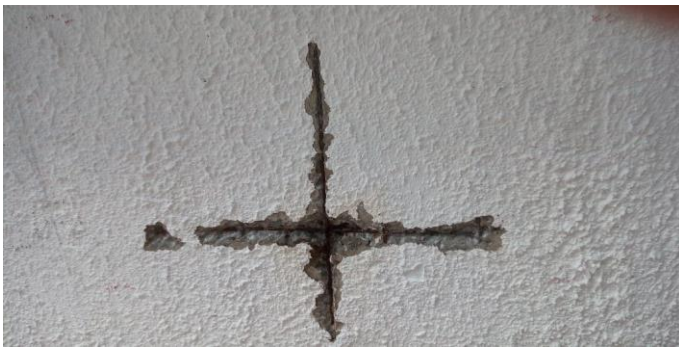
- The reinforcement in this area is slightly oxidized.

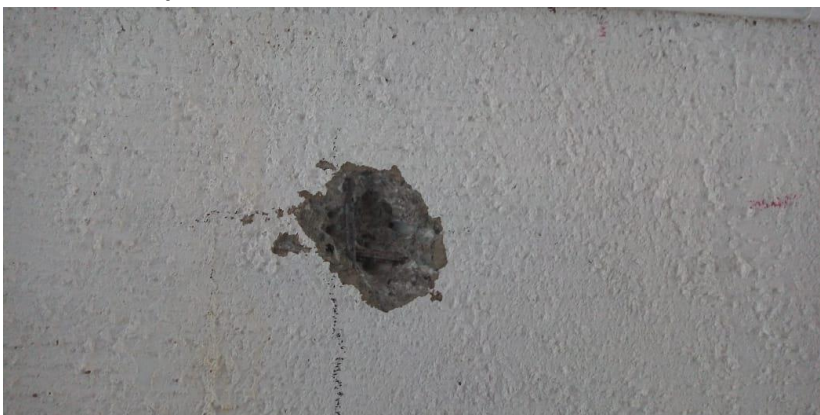
Additional Exposure

- An additional exposure was completed approximately 1m from the damp leaking area.
- No oxidation was found on this reinforcement.

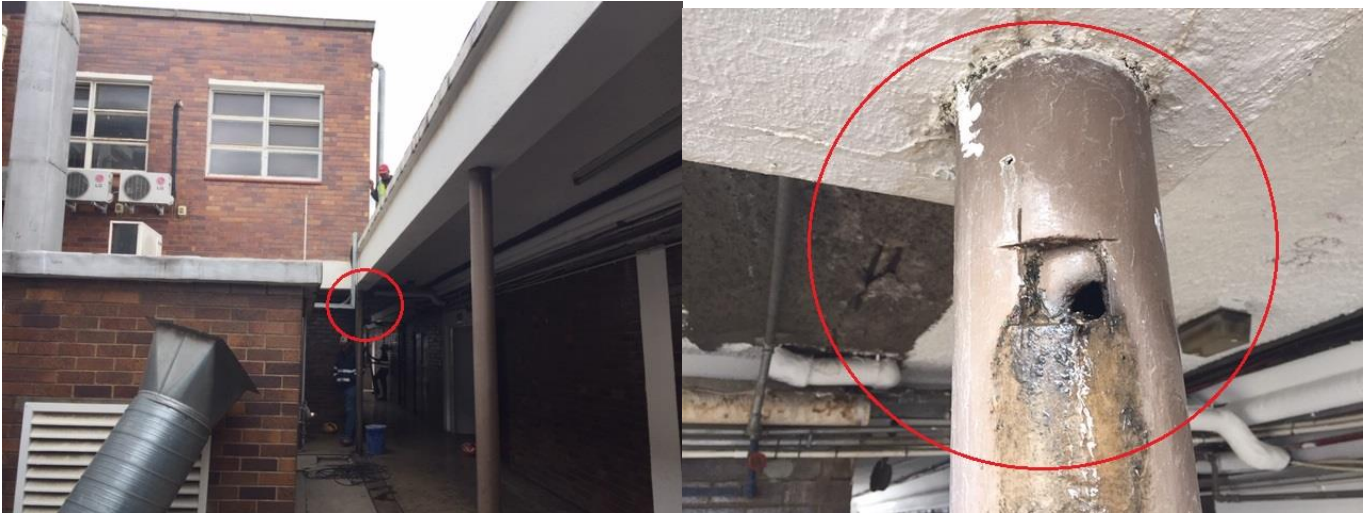
Further observations

- The steel column in the image above has a drain pipe within its centre.
- This pipe has blocked up sometime in the past.
- A part of this column has been cut to allow the escape of drain water and therefore has been weakened.
- Due to its position we suspect this column is load bearing.
